UNDERWATER BRIDGE INSPECTION REPORT

STRUCTURE NO. L8159

MISSISSIPPI RIVER OVERFLOW

DISTRICT 9 - WASHINGTON COUNTY, CITY OF COTTAGE GROVE

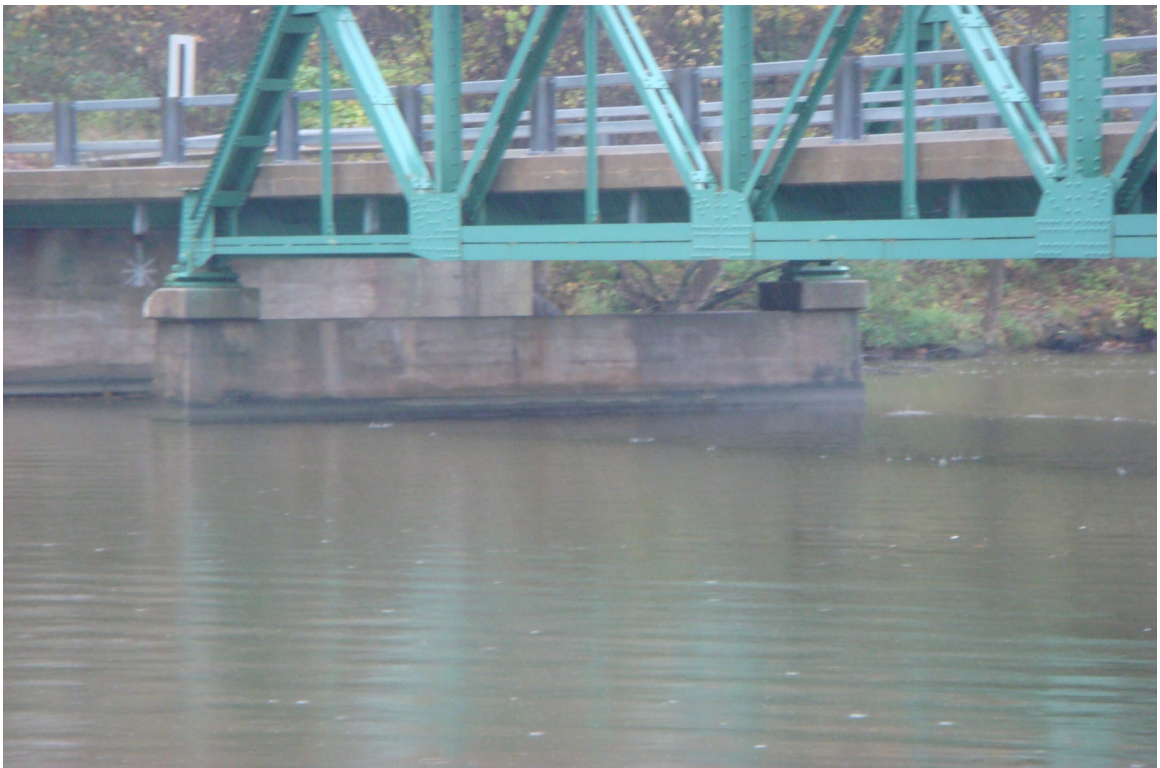
Photograph 2. View of Pier 1, Looking Northwest.

- 2 The footing at the upstream end of Pier 1 was exposed with up to 3 feet of vertical face exposure at the North corner.
- 3 The footing at the downstream end of Pier 1 was exposed with up to 2 feet of vertical exposure.

- 4 A 6-inch-wide band of minor scaling was observed at the waterline at Piers 1 and 2.
- 5 An area of section loss, 3 inches in diameter, was observed 6 inches above the channel bottom on the upstream end of Pier 2 with up to 1 inch of penetration.

- 6 Two areas of section loss, 6 inches in height and 12 inches wide, were observed 4 feet below the waterline with up to 1 inch of penetration.
- 7 An area of section loss, 6 inches in diameter, was observed on the corner at the channel bottom with up to 2 inches of penetration.

- 8 An area of section loss, 8 inches in diameter, was observed at the waterline with 1.5 inches of penetration.
- 9 The channel bottom consisted of sand, riprap, and broken concrete with no appreciable probe rod penetration.

No plans for the structure were available at the time of the inspection. It is recommended that existing plans be reviewed to determine the foundation type and depth at Pier 1 in regard to the footing exposure. It is also recommended that the scour analysis be reviewed to determine if the exposed footing was considered and/or expected in the coding of Item 113. Based on the above review, counter measures could be warranted, such as placing riprap around the exposed footing at Pier 1 to prevent further exposure.

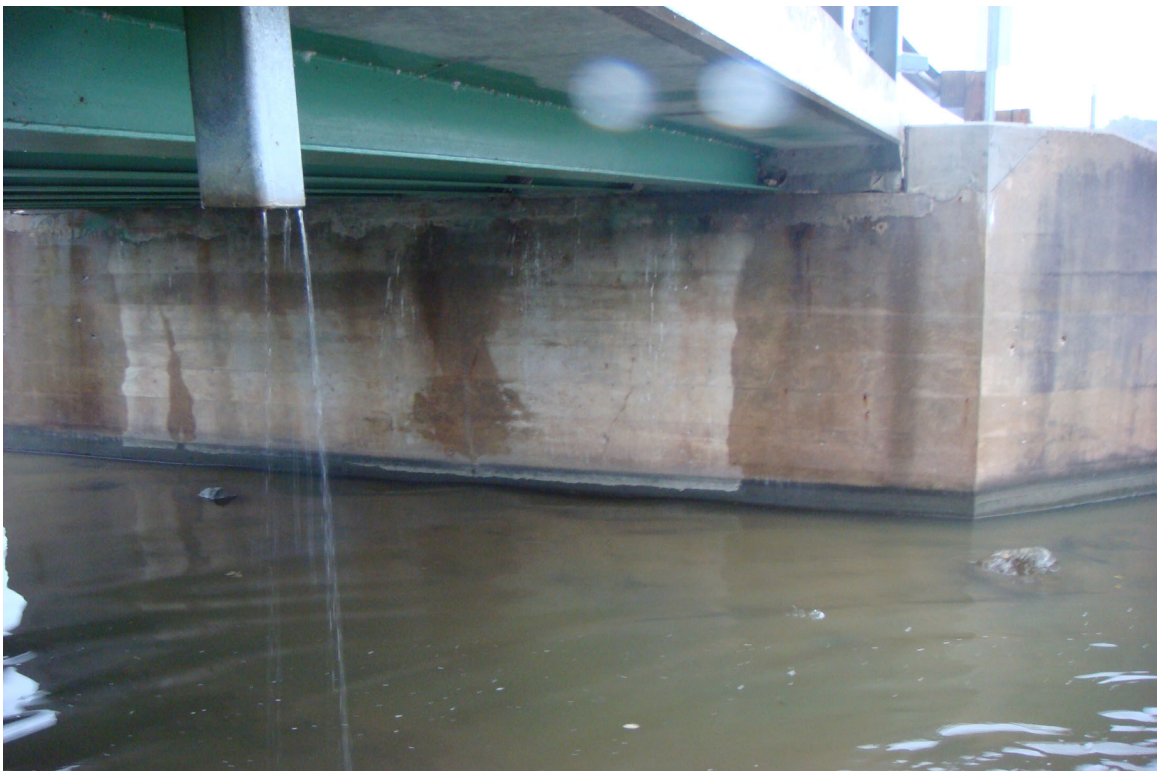
Photograph 4. View of East Abutment, Looking Northeast.

- 1 Three evenly spaced vertical hairline cracks were observed at the center of the East Abutment from the top of the abutment to 1 foot above the waterline.

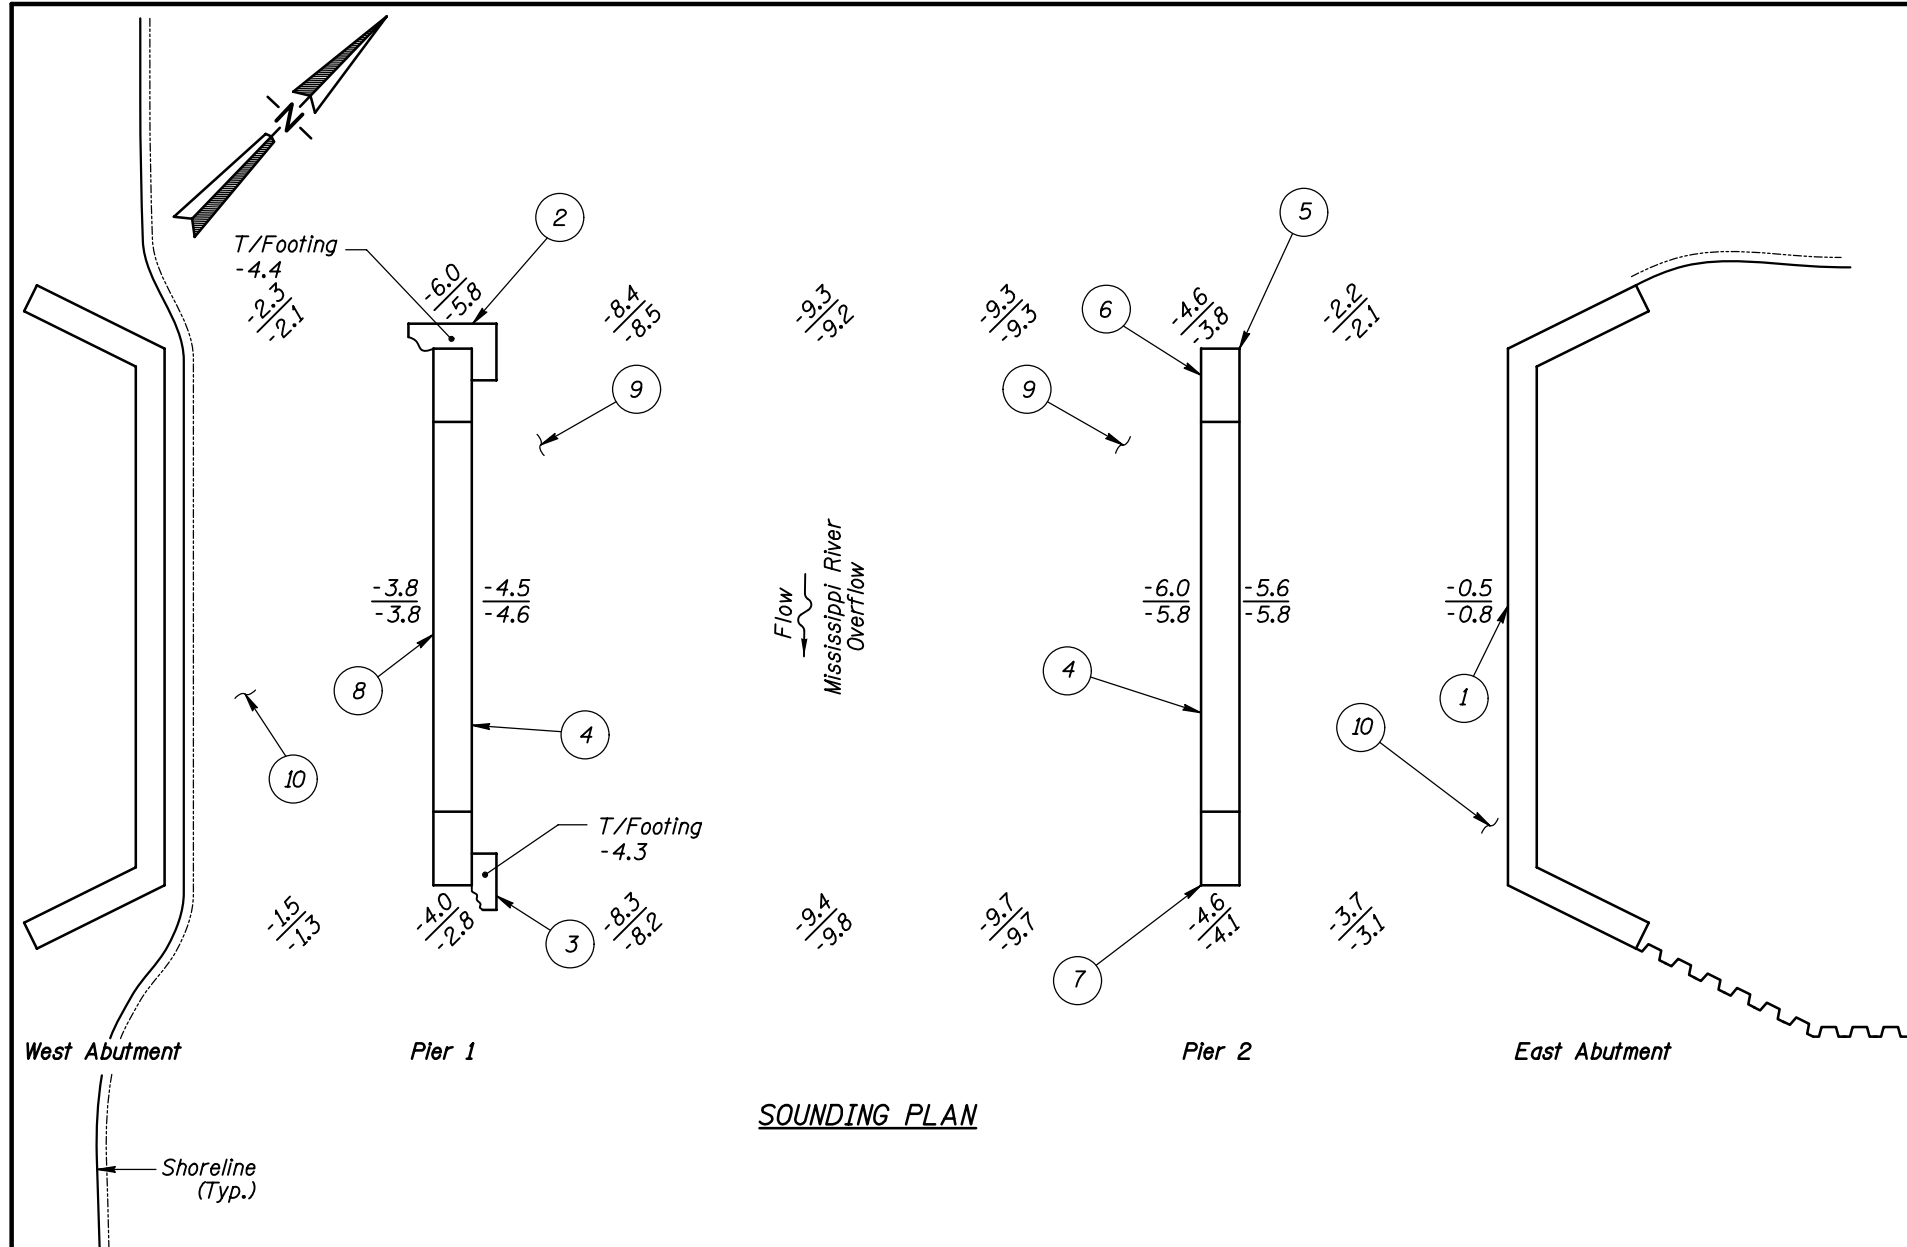
SOUNDING PLAN

- 10 The channel bottom consisted of firm sandy gravel with a maximum probe rod penetration of 1 inch.
